Production status of Japan

- Production and QC steps
- Results of ASIC Hybrids
 - Yield summary
- Results of Modules
 - Mechanical
 - Electrical: Leakage current, defective channels
- Yield summary

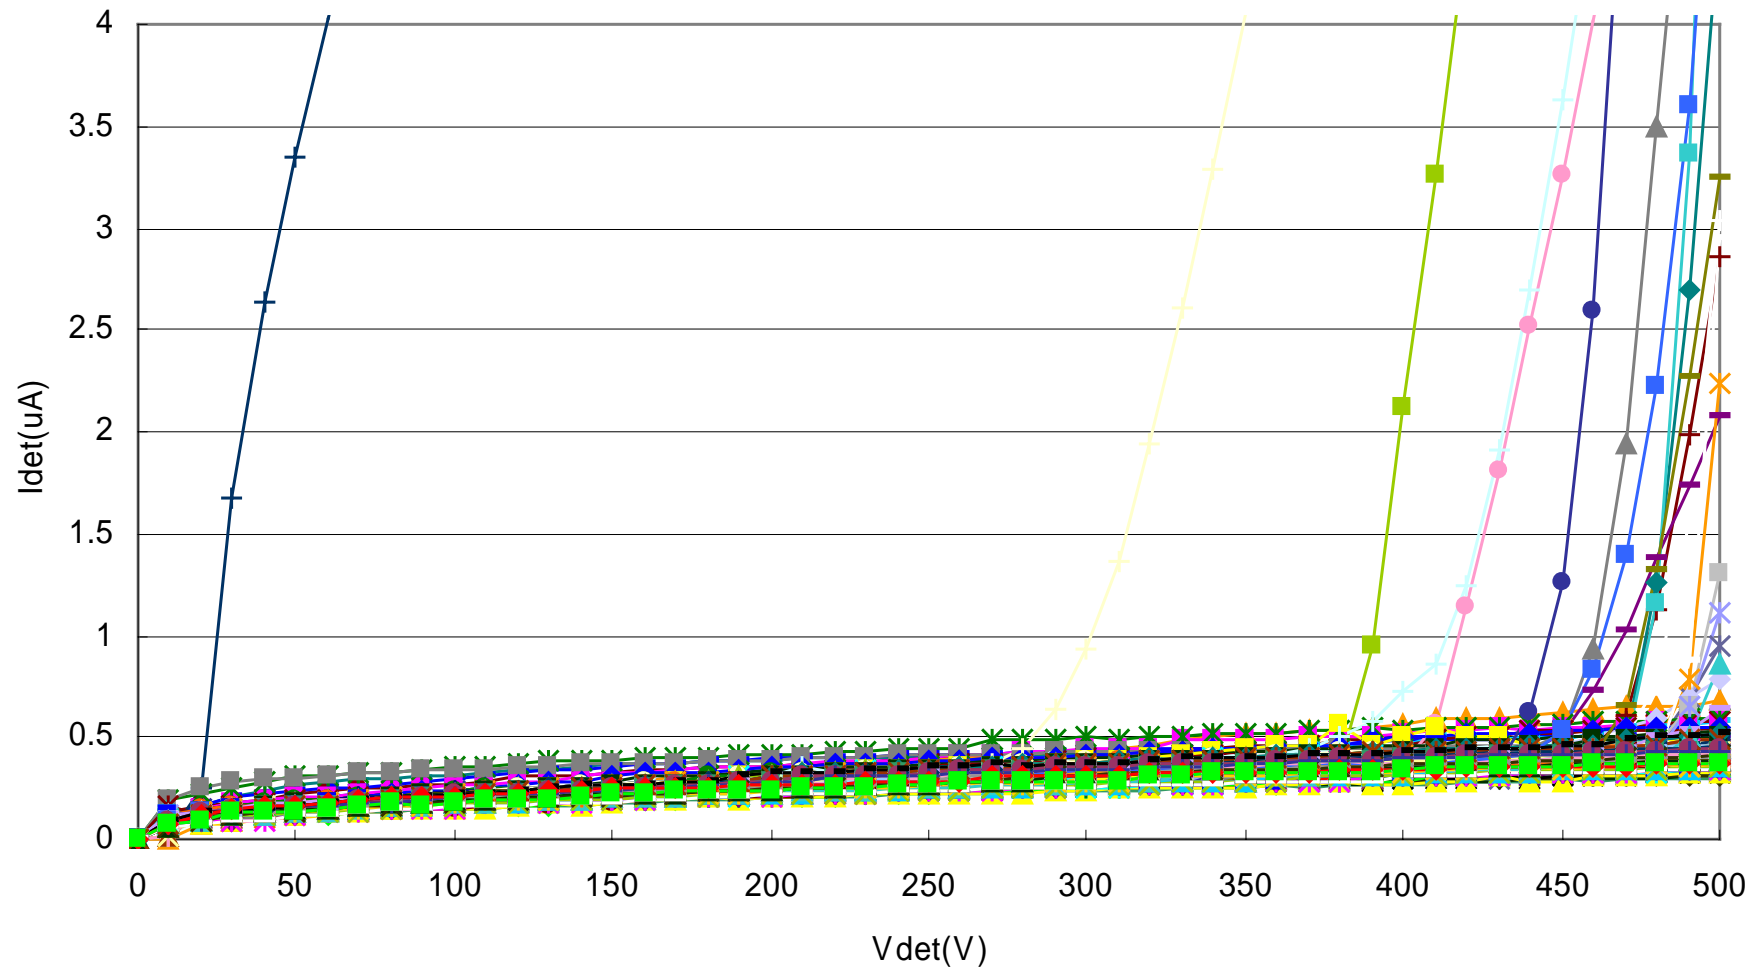
Modules #1 - #200

Leakage Current Measurement

IV curve_mDaqLT_@20°C

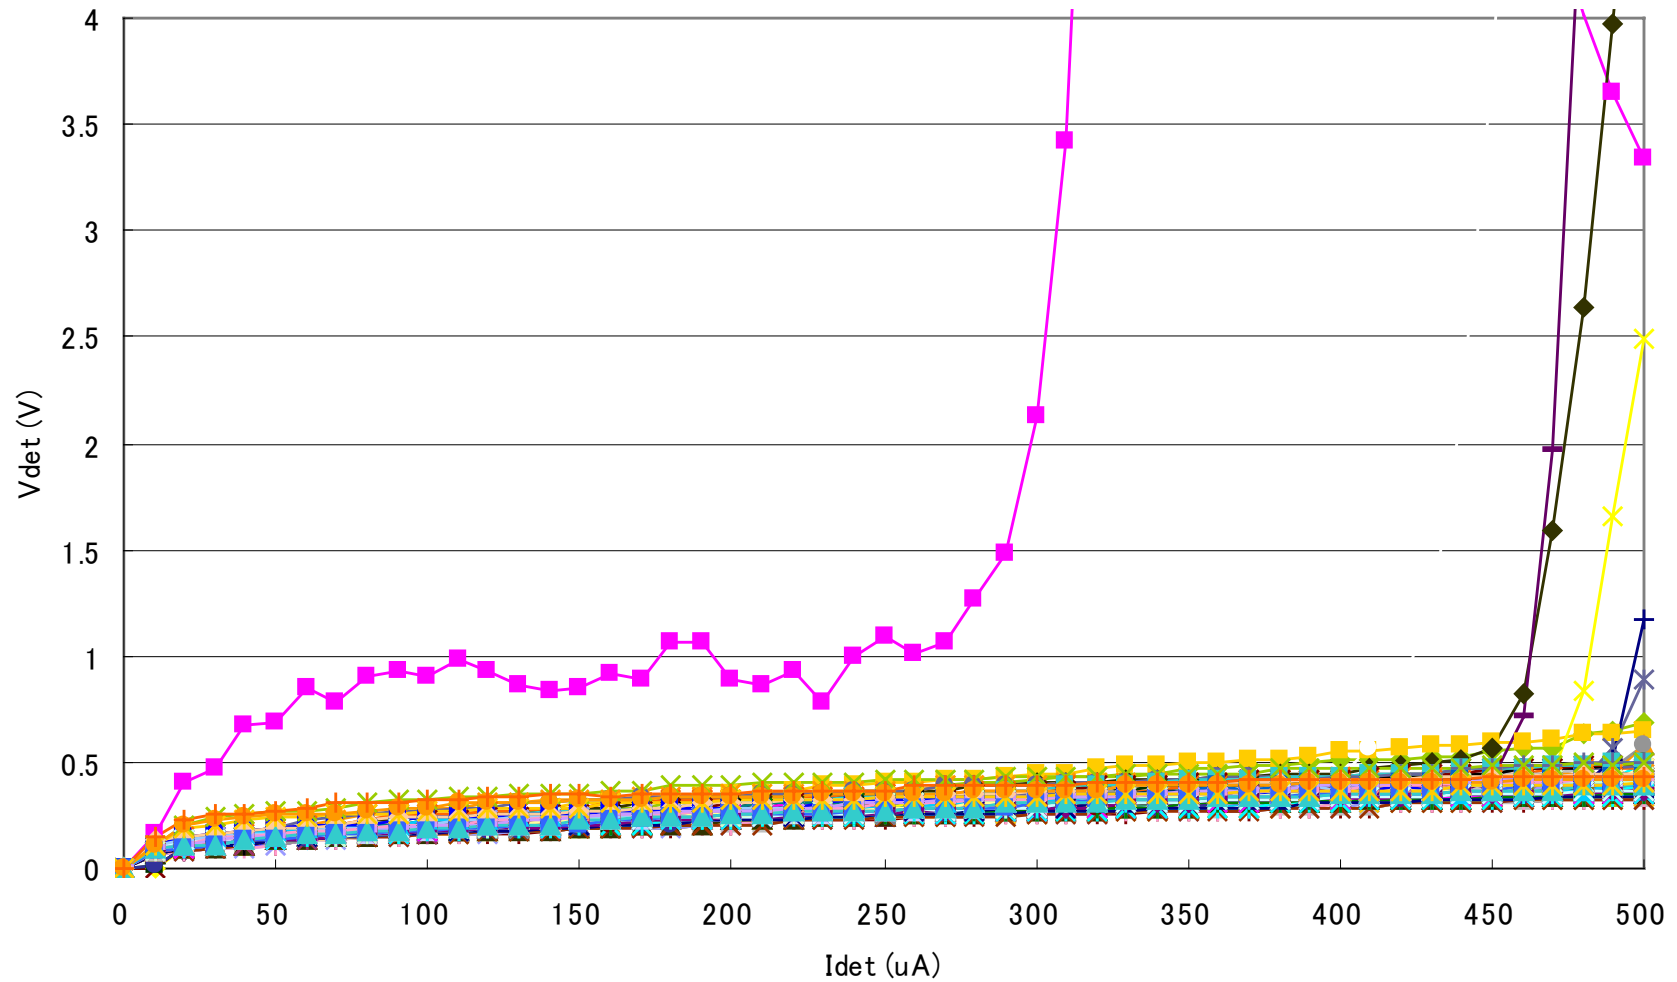
Modules #200 - #374

Leakage Current Measurement

IV curve_mDaqLT_@20°C

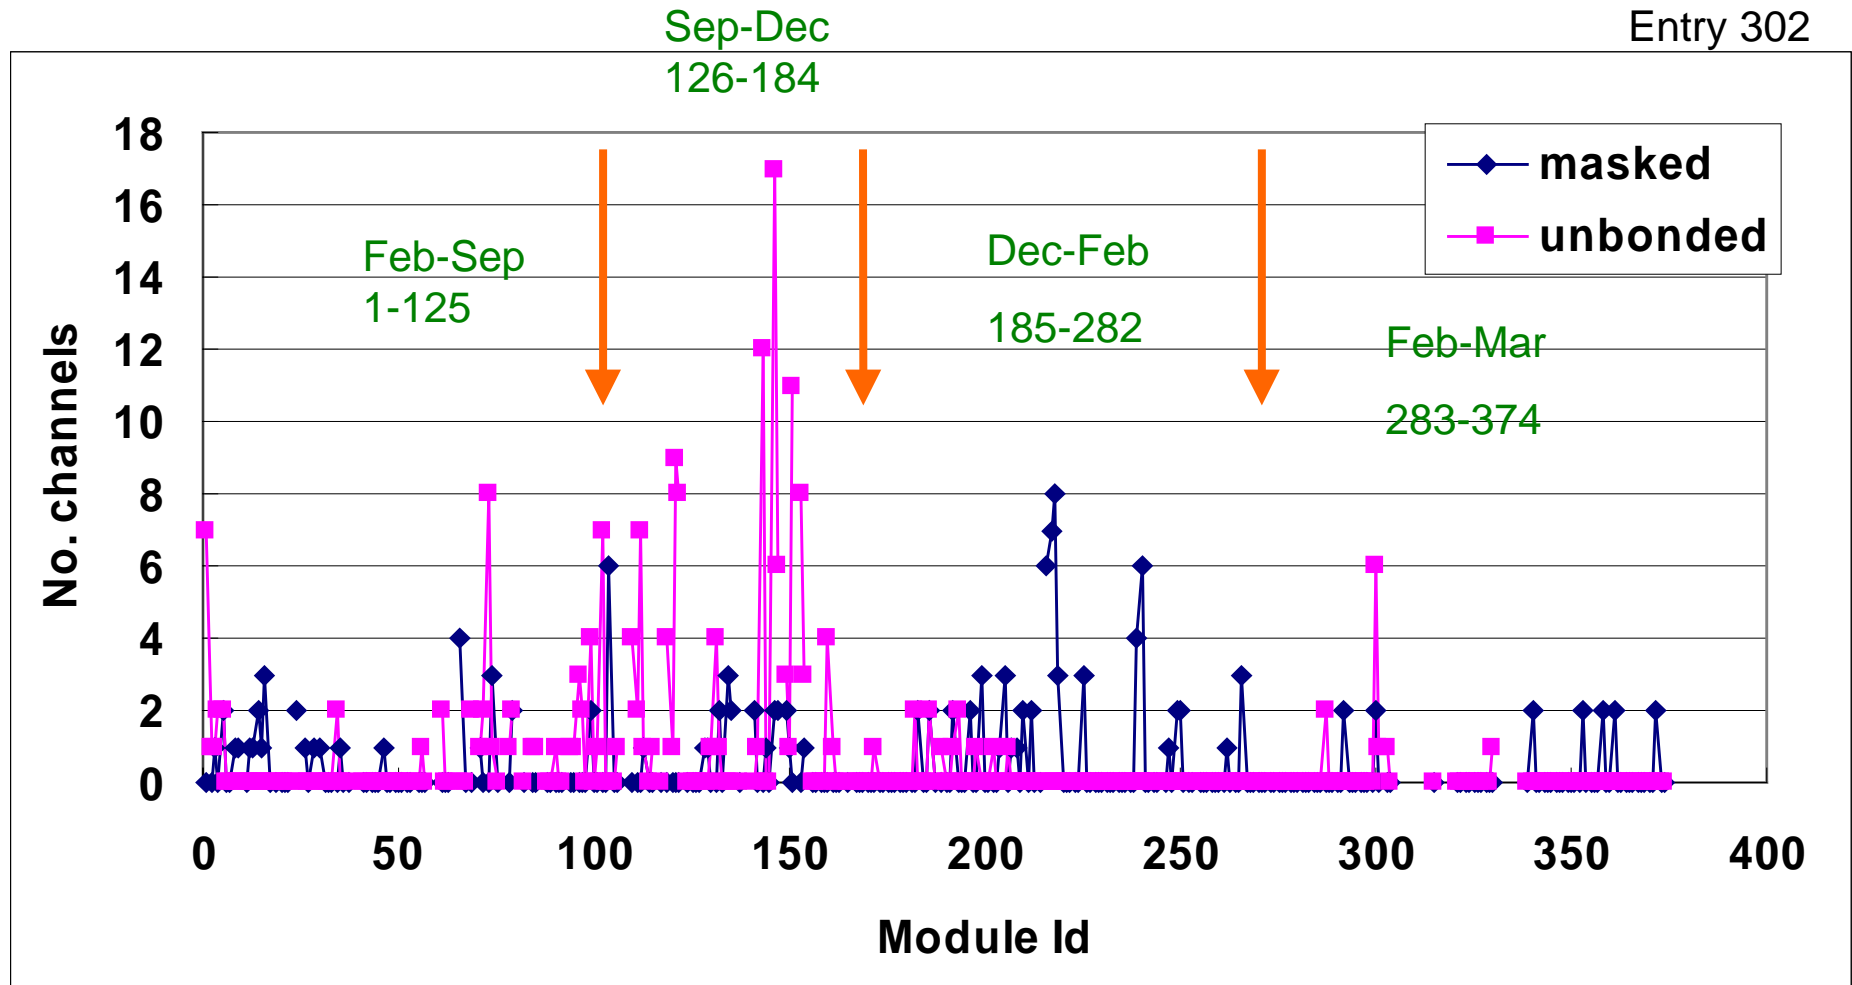
Defective Channels in Modules

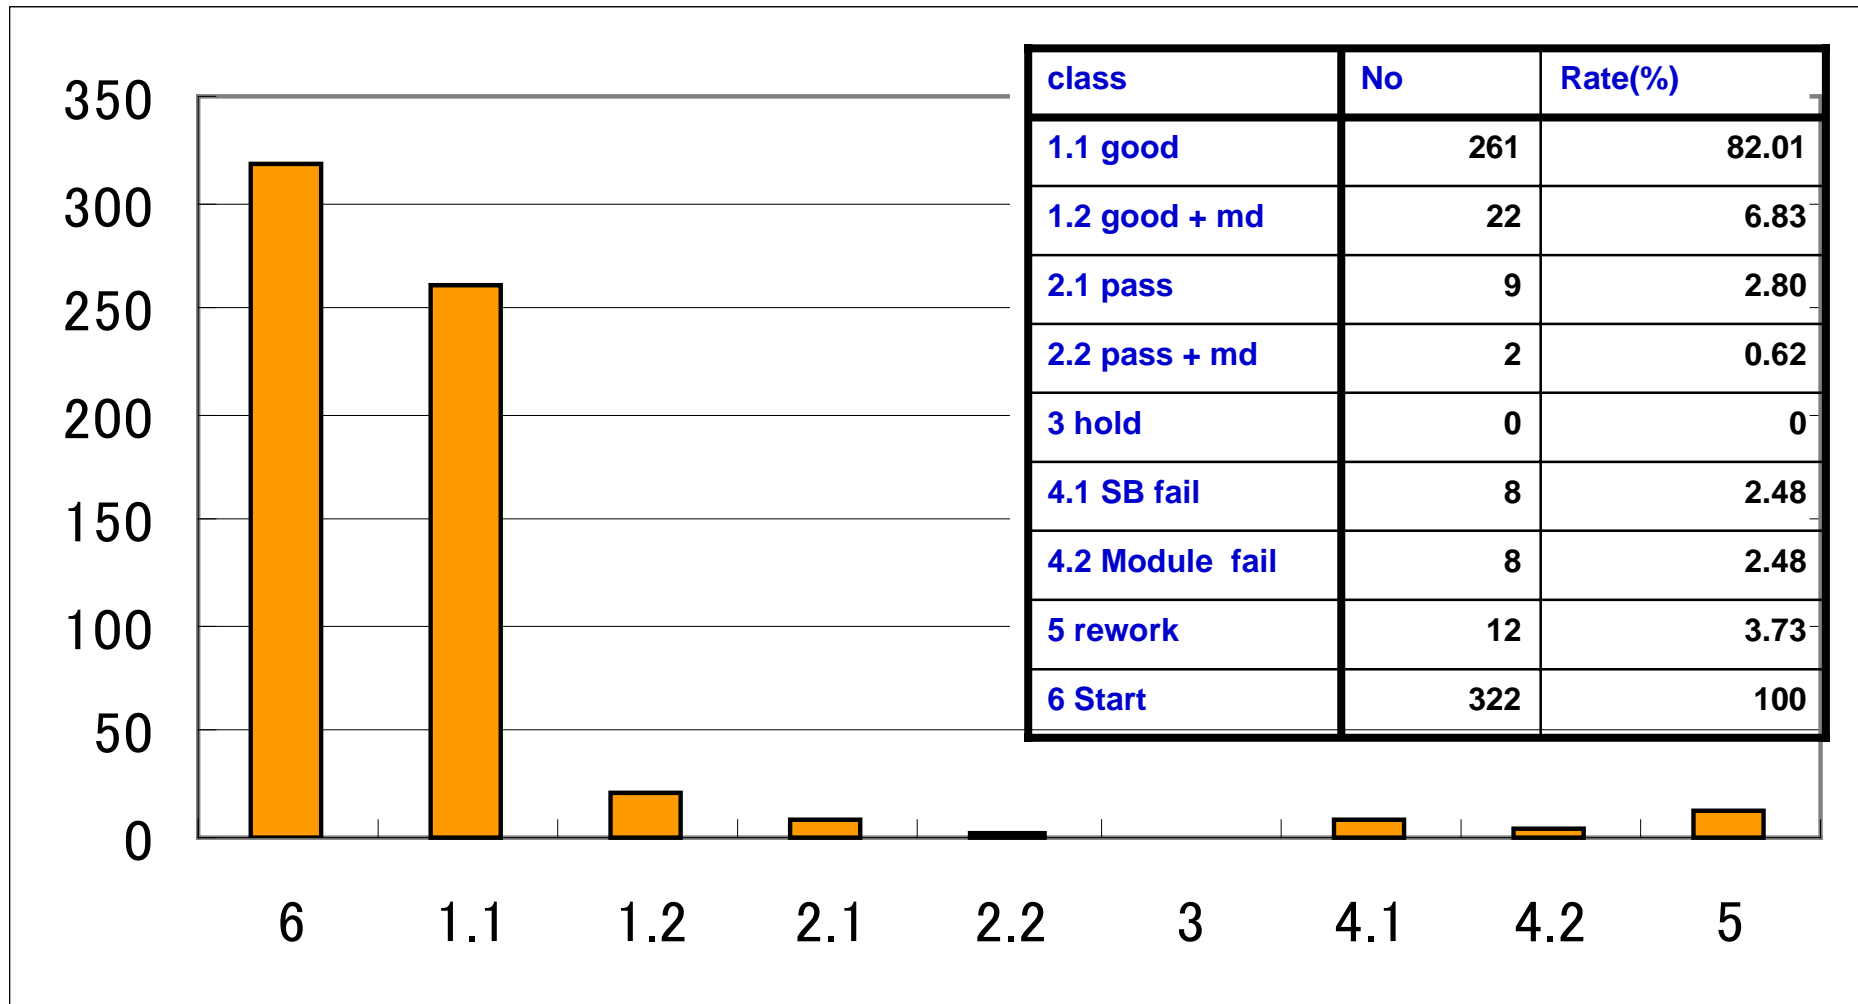
Module Class Categories
