# Zapping a chip in a module in Japan

Y. Unno, SCT week, 23 Sep 2003

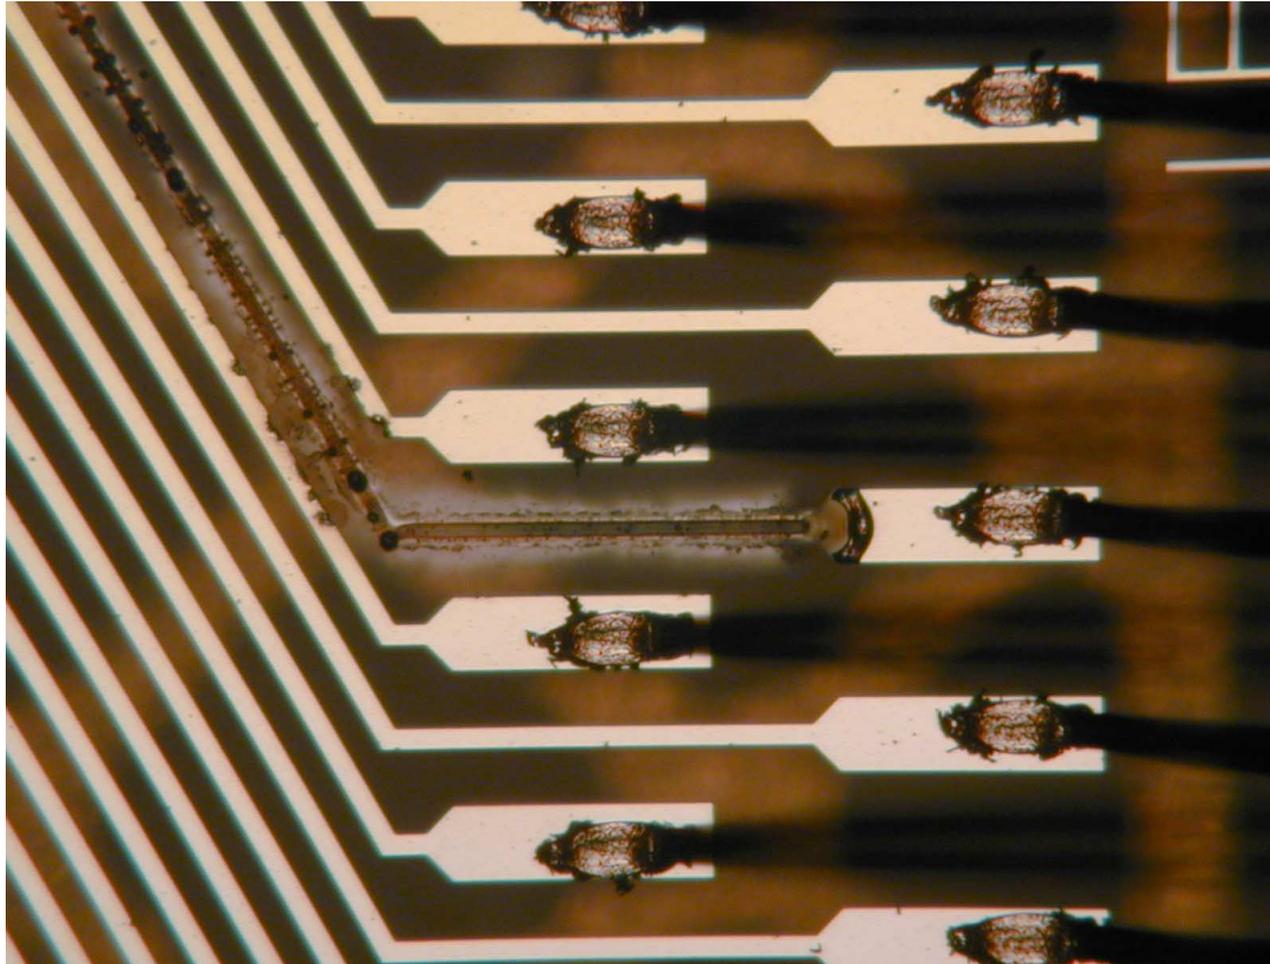
- Hybrid/Module - 20220170200469
- Only one incident out of about 500 modules
- All chips alive in Hybrid QA, then one chip (M00) found dead in Module QA
- Visual inspection found a burned trace on PA, and further, burned traces in a chip

# Burned trace in PA

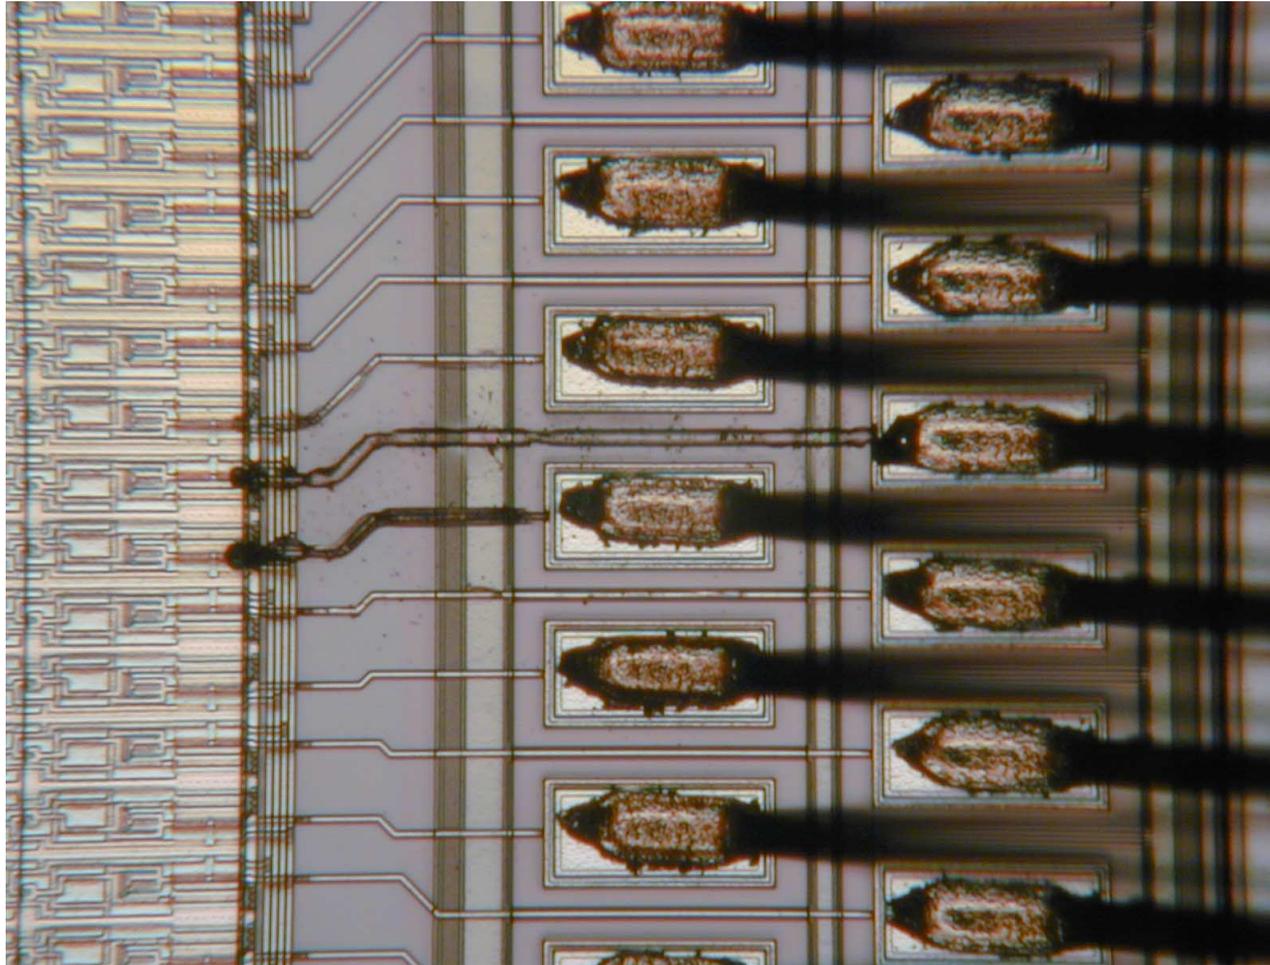
# Burned trace in chip

- The zapping of a chip was caused by the short between an Al wire (GND) and the sensor edge (HV) due to a metal debris, "shaved coil"
- There is a HV resistor of 10 kOhm to the backplane, but this did not protect the chip from the short
- A pinhole strip exists in a sensor, strip no. 208, which did not correspond to the strips of the zapped chip (strip no. 1-128)
- A careful investigation is required for the cases where the HV reaches or a large current flows into the chip through pinhole strips, e.g. shortening the body of sensor by the splash of beam
  - can be simulated with a flash of light?

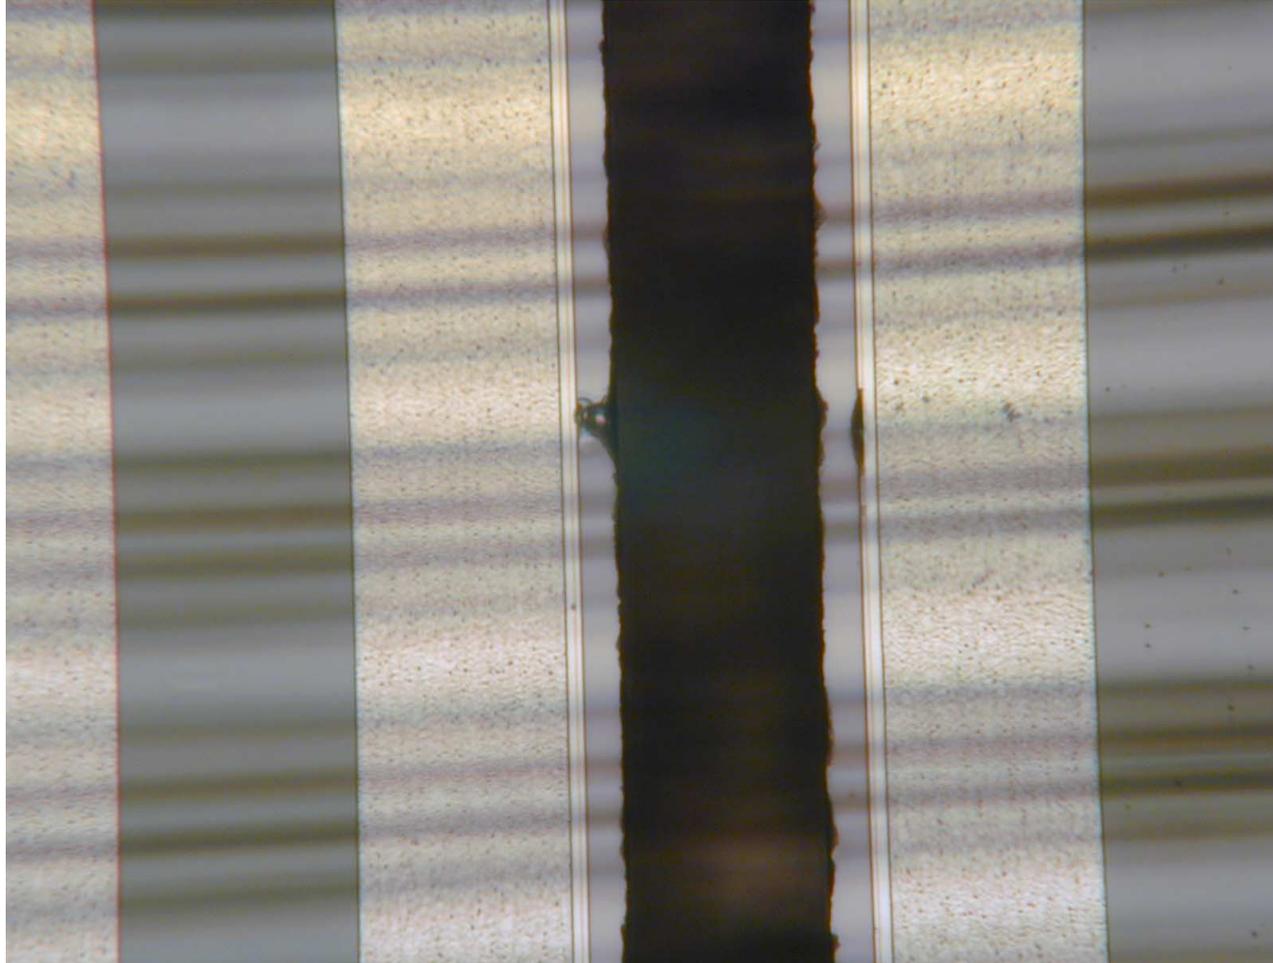
- Visual inspection revealed a trace of lightning in the edge of the sensor (and maybe in the Al metal?)
- A "shaved coil" was found nearby on the surface on sensor. The shaved coils from the Al wire are seen, rare but occasionally. This shaving may be specific of the wire-bonding machine
- The ends of the "coil" seems rounded because of lightning
- Such a "shaved coil" caused discharge in a module previously

# The source?

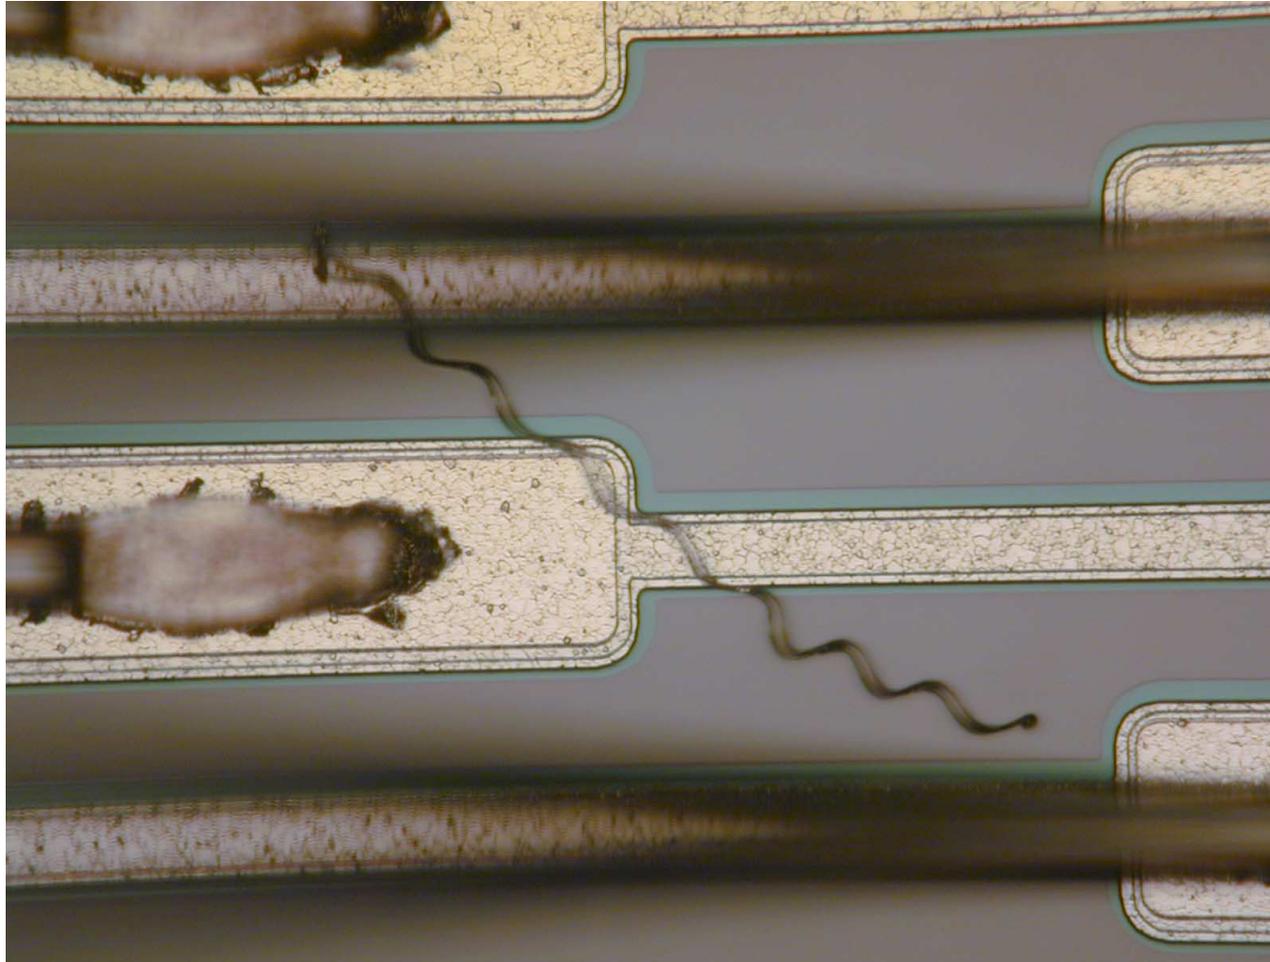
# Shaved coil
