Microdischarge debug with CCD

SCT week December 2002

ATLAS Japan Silicon group

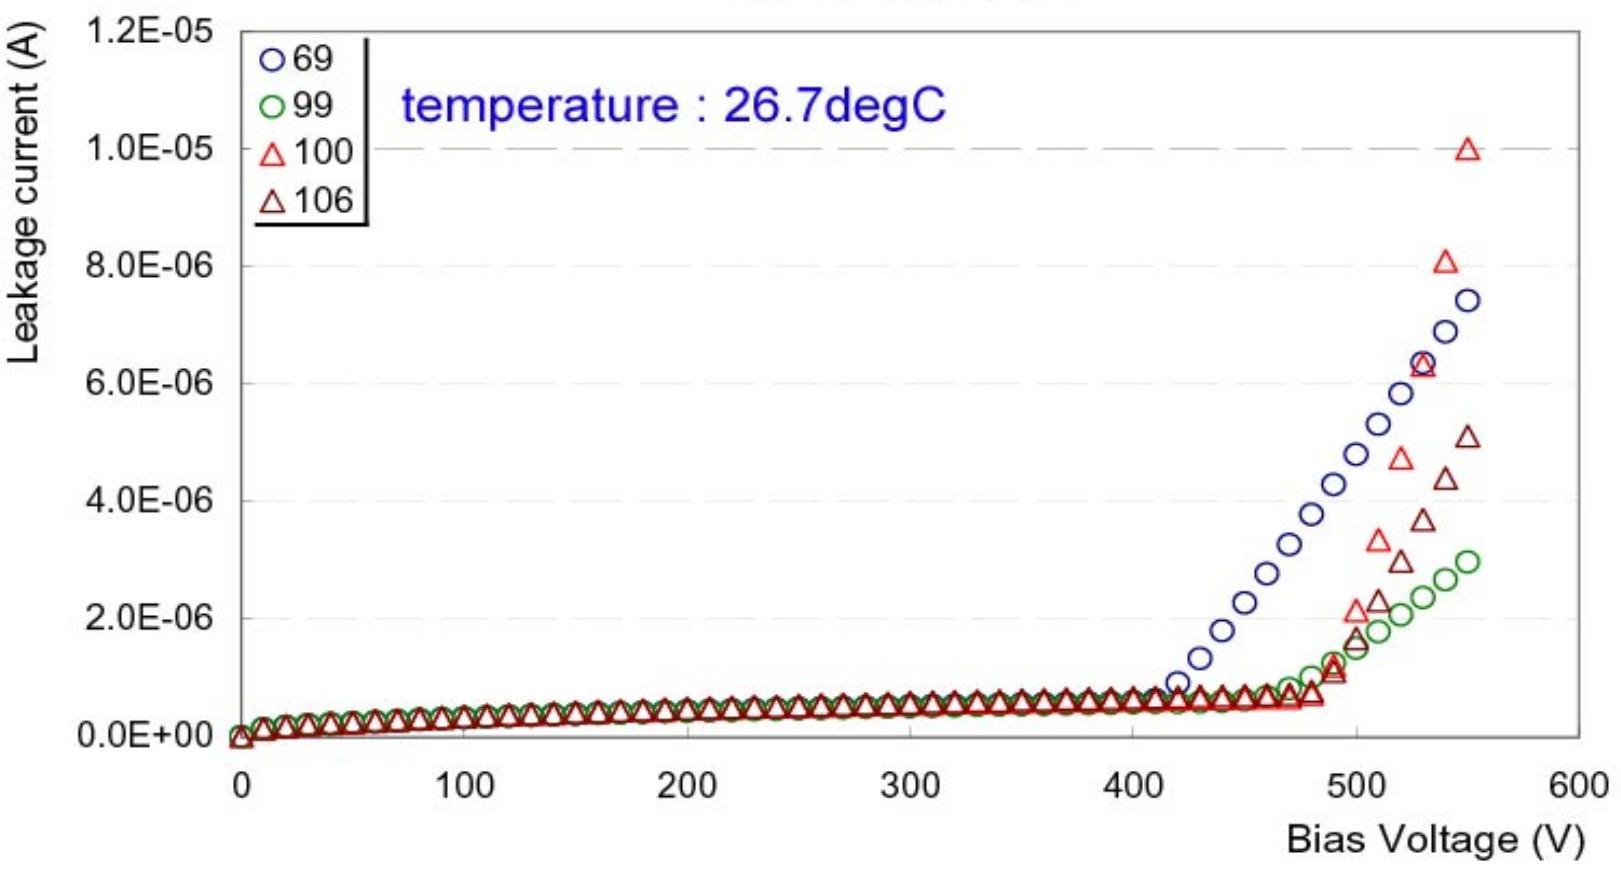
IV characteristics

Microdischarge appeared above 400 V.

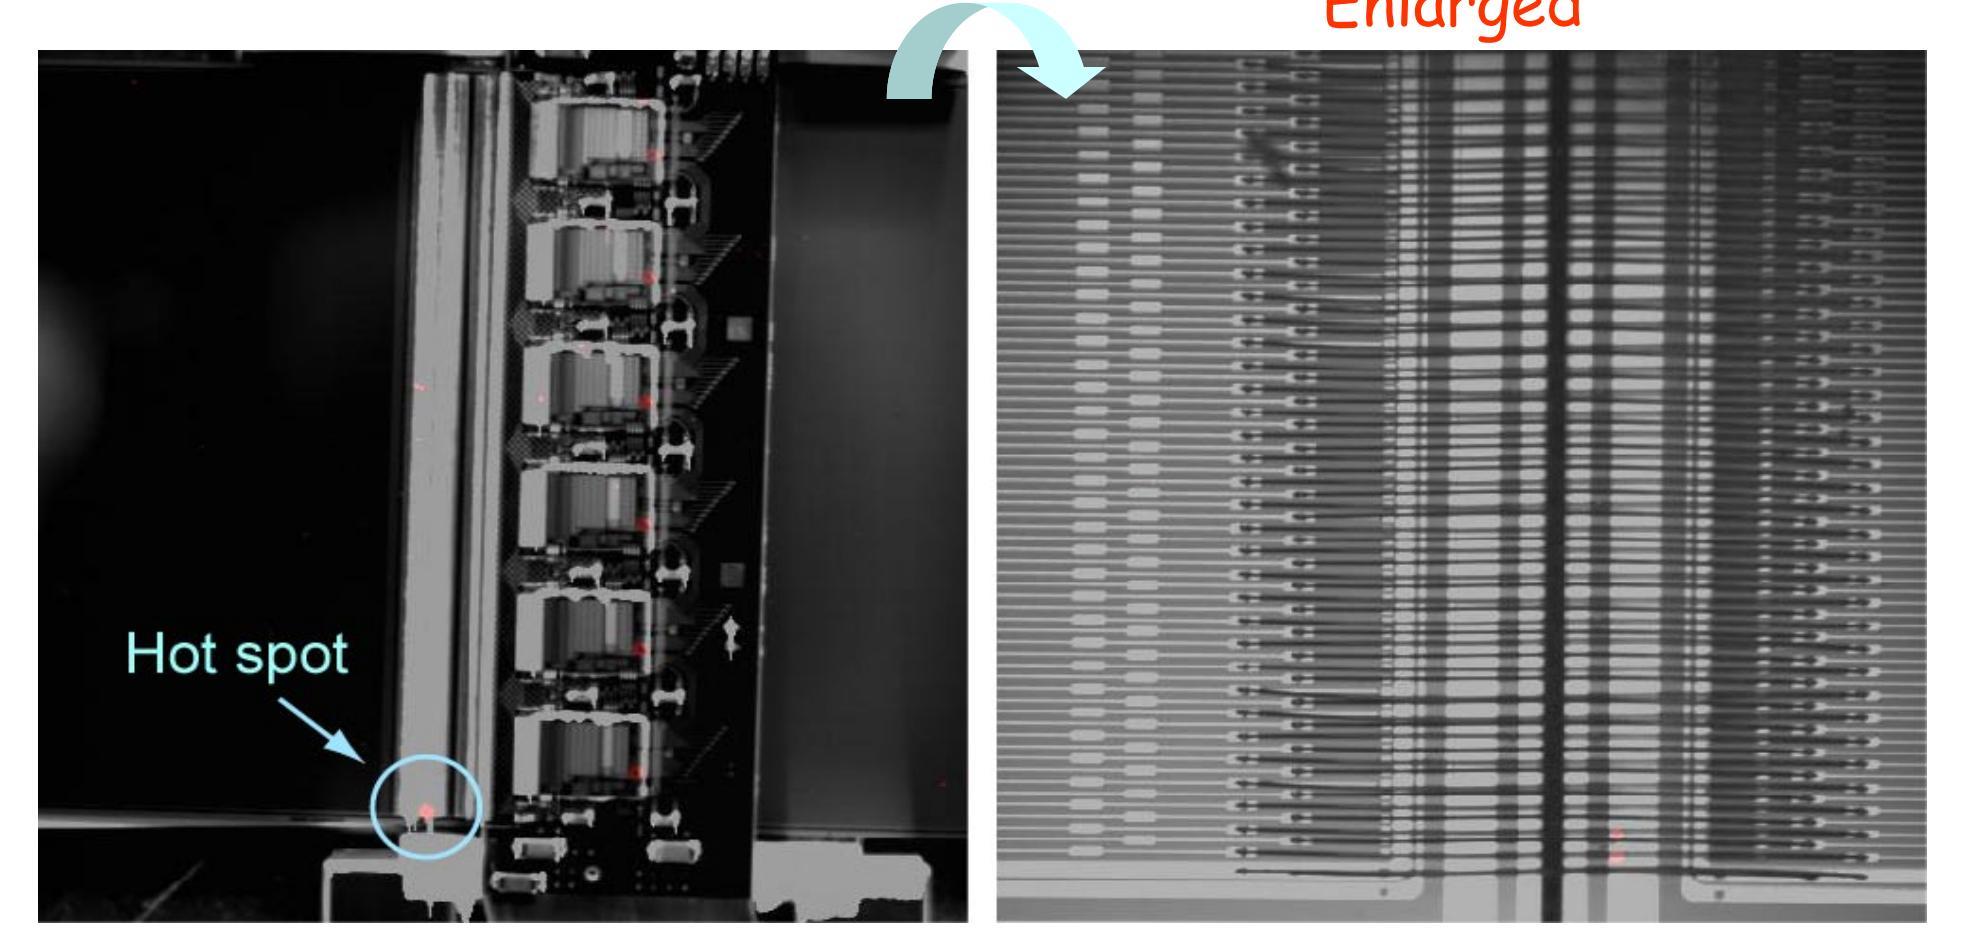
5. Results ID = 100 (the biggest current @ 550 V) Hot spot was observed on the sensor 4 (backside of the module). Enlarged

(X 2 maginification)

The cause of hot spot is investigated by the visual inspection.

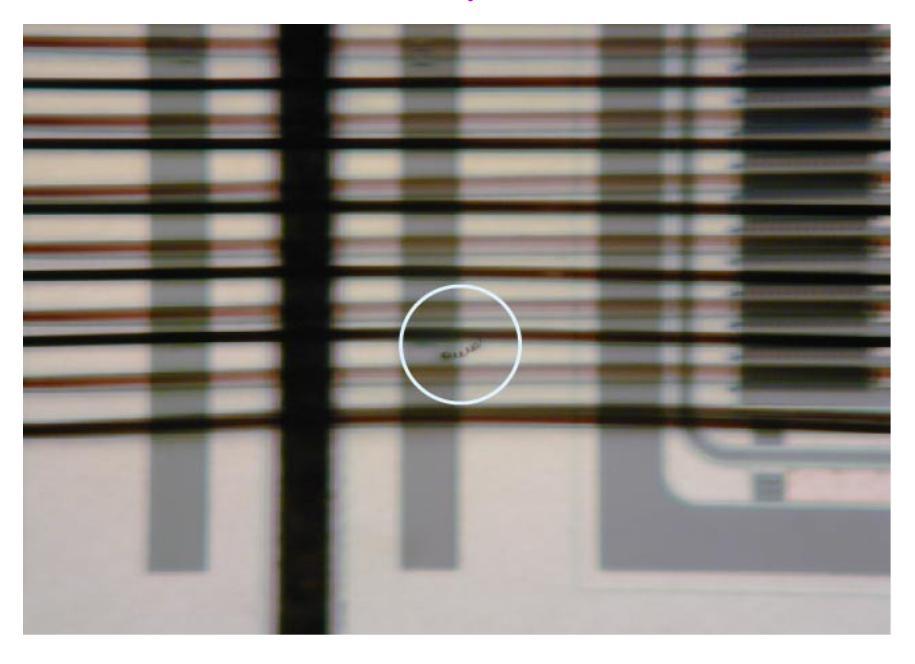
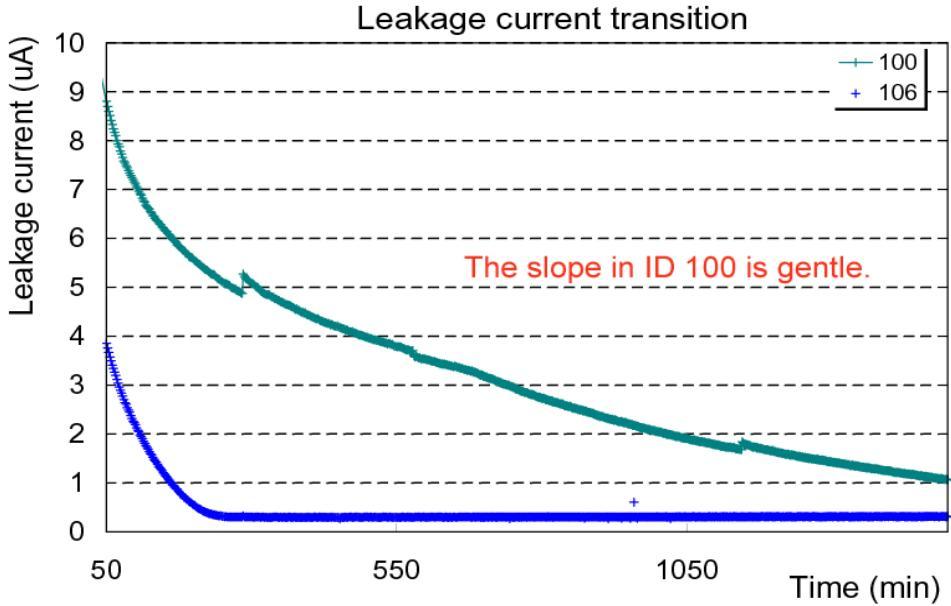
The cause of hot spot was a shave off a bonding wire.

Because of the contact, decay time of microdischarge is longer.

It was in contact with the surface of detector.

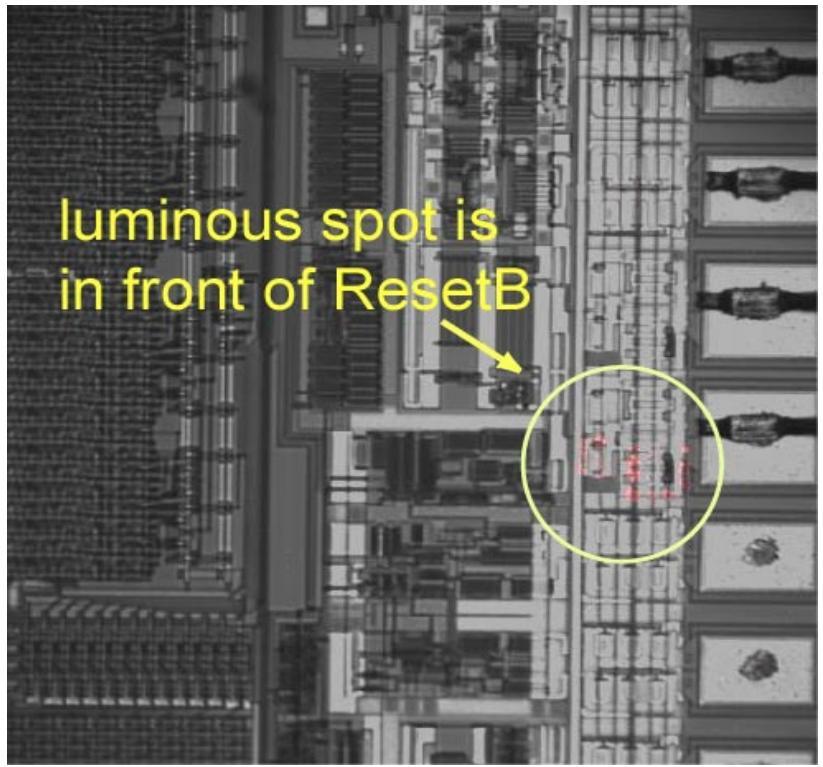
x10 magnification

We still found the luminous spots. The enlarged view of the luminous spot is ...

According to chip designer: "The luminous spot is due to a diode for the prevention of ESD.

When the difference of potential between Vdd and Reset B is larger than 0.6 V, the diode starts working."

ResetB = 1.5 V @ Vdd off

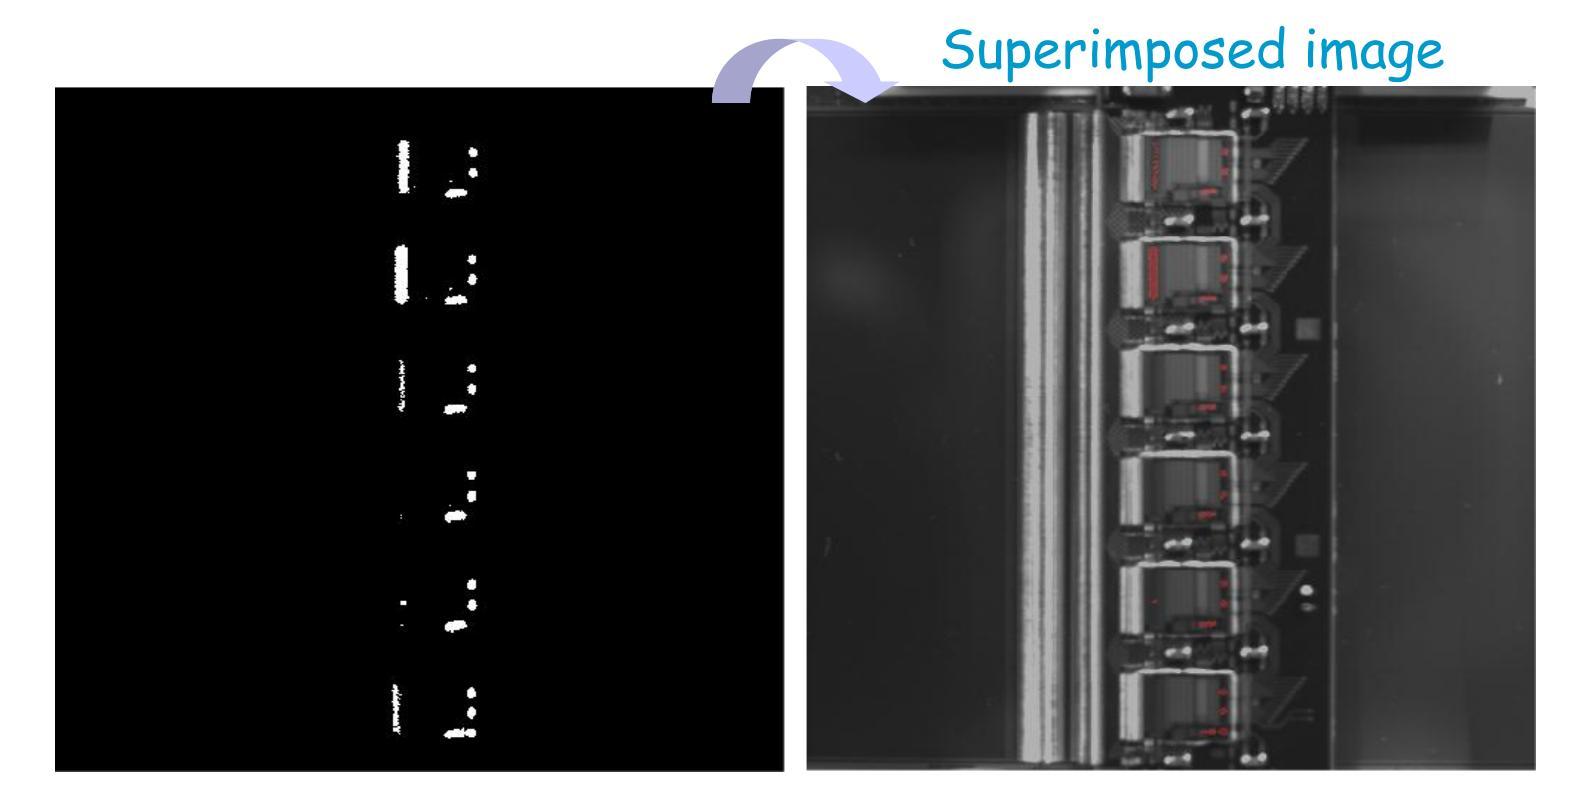
ResetB = 4.5 V @ Vdd on (design value : 4.0 V)

Previous spots disappeared. Other luminous spots were due to heat in the ASICs.

Working correctly !!
