SCT Barrel "PC" Hybrid Status

Japanese SCT group

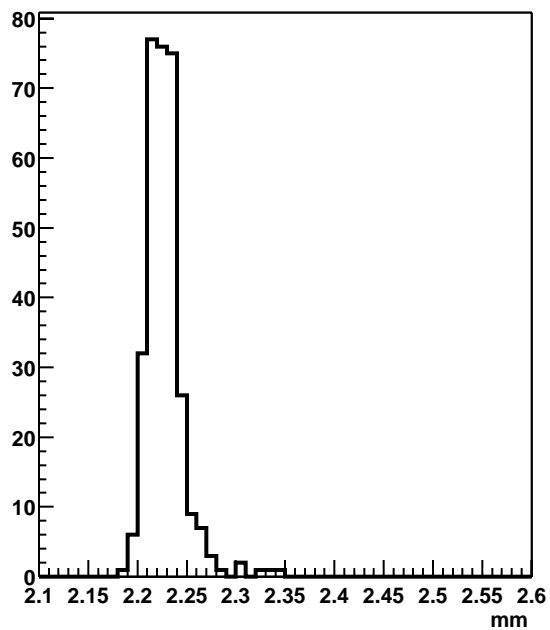
Height of Component C53 (mm)

Entries 318

- Thickness; $620 \pm 50 \mu\text{m}$
- Flatness
 - Bow (long); $< 75 \mu\text{m}$
 - Bow (short); $< 75 \mu\text{m}$
 - Twist; $< 100 \mu\text{m}$
- Height of the critical components (after TC only)
 - $< 2.63 \text{ mm}$

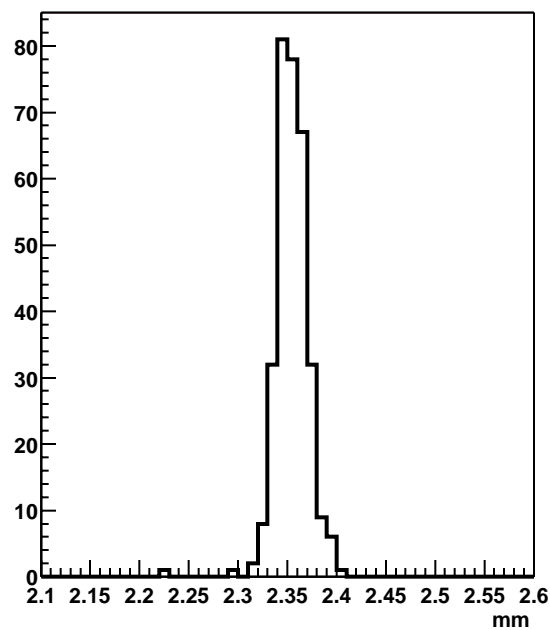
Height of Component C54 (mm)

Entries 318

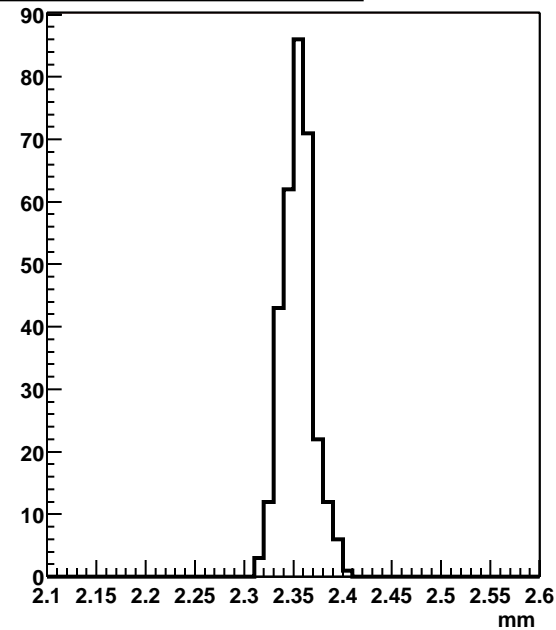
Height of Component C73 (mm)

Entries 318

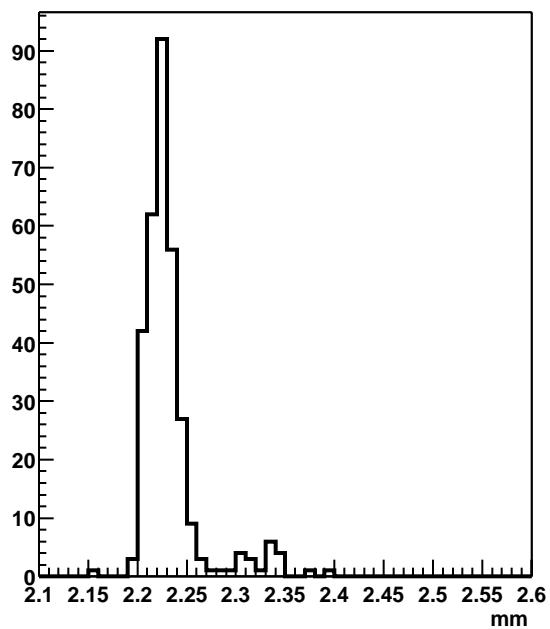
Height of Component C55 (mm)

Entries 318

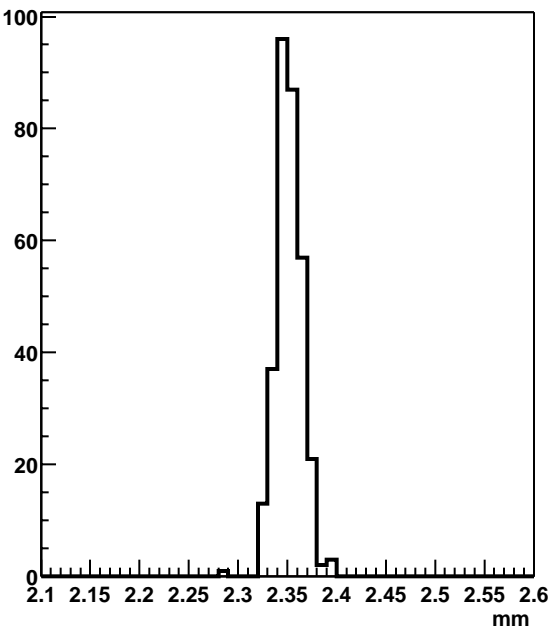
Height of Component C56 (mm)

Entries 318

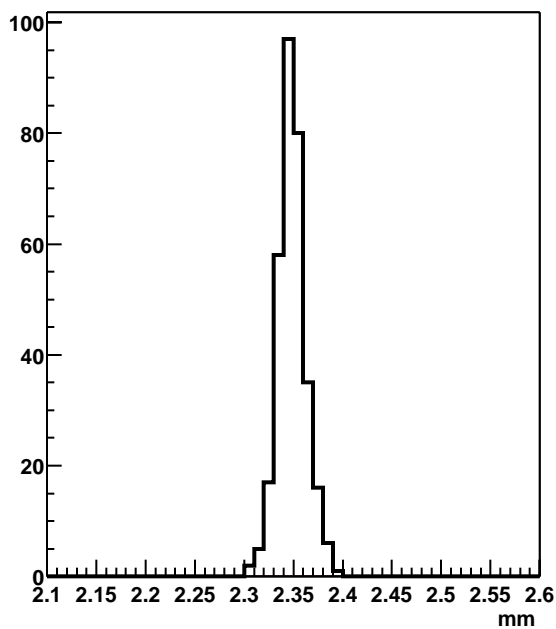
Height of Component C74 (mm)

Entries 318

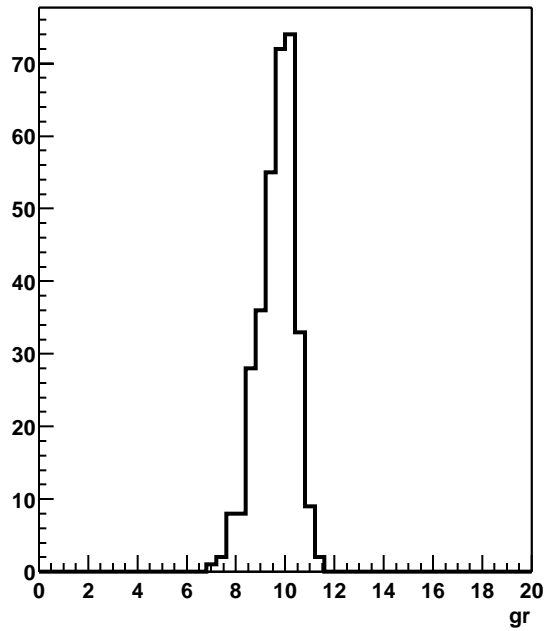
WB pull average (hybrid)

Entries 328

- Flex. PC bond test
 - Four test pads (one wire/pad) /FPC;
 - $> 6 \text{ gr}$
- Pitch adapter bond test
 - 10 places/lot ;
 - $> 6 \text{ gr}$
 - (25 PAs'/sheet, 10 sheets/lot)

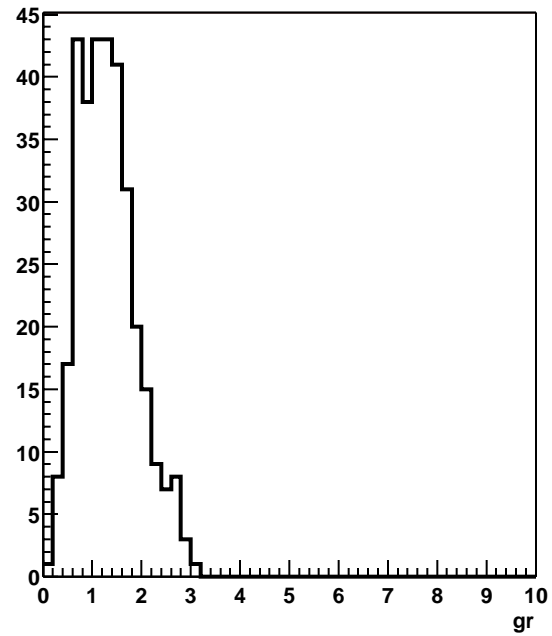
WB pull range (hybrid)

Entries 328

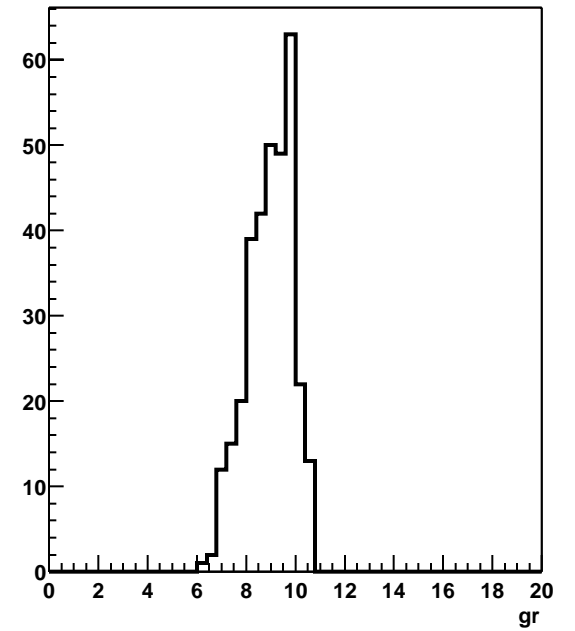
WB pull min (hybrid)

Entries 328

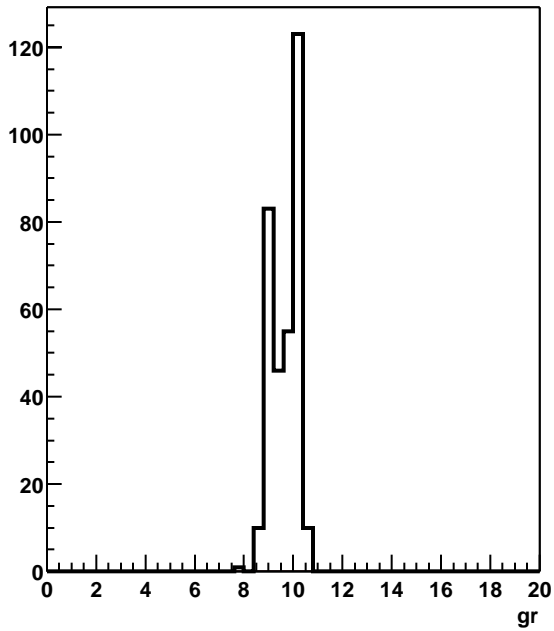
WB pull average (PA)

Entries 328

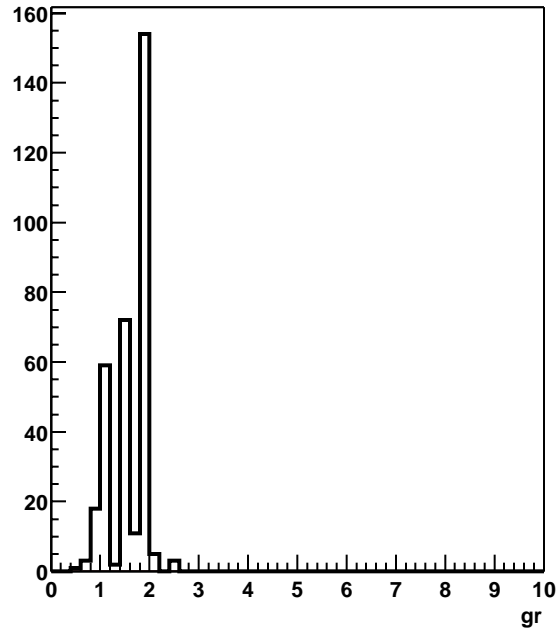
WB pull range (PA)

Entries 328

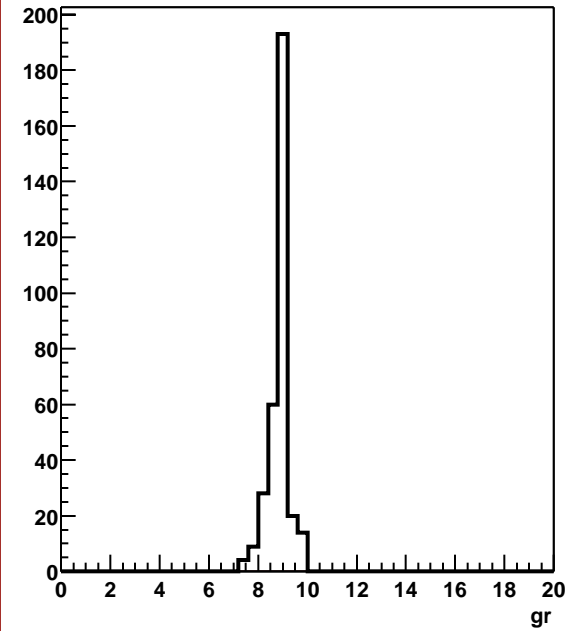
WB pull min (PA)

Entries 328
