Results of early phase of series production of ATLAS SCT barrel hybrids and modules

Abstract

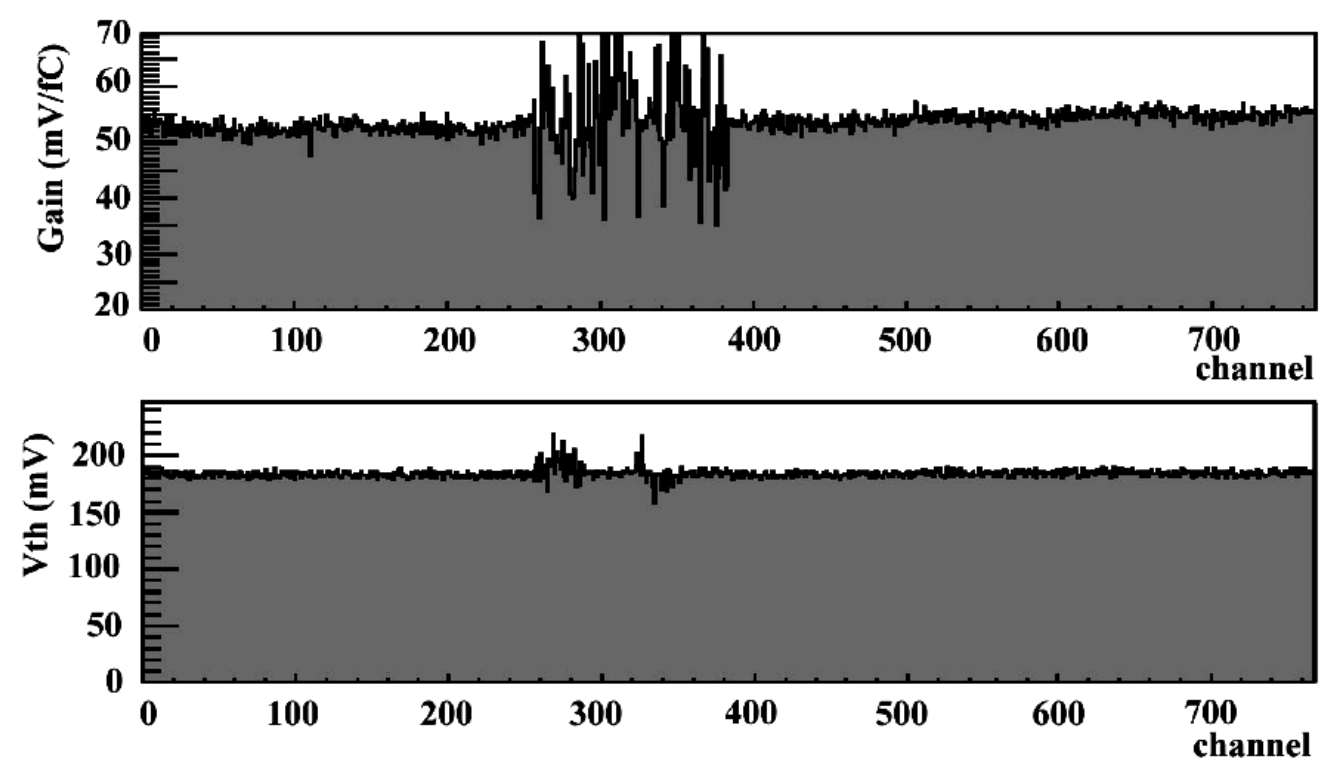
Out of the electrical tests, defects in ASIC's were classified. The channels that were defective and subsequently masked by the channel mask registers in front of the pipeline buffers were, completely inefficient (DEAD), always on (STUCK), or un-trimmable (UNTRIMMABLE) channels. These channels were eventually become dead by masking. The channels that had a bit error in the pipeline buffers or after and showed prevailing hits were STUCKCELL channels. This defect is severe because it produces unnecessary traffic. The ASIC's which had all 128 channels DEAD, STUCK, or UNTRIMMABLE, were classified as DEAD ASIC's. The ASIC's which had one or more STUCKCELL channels were classified as STUCKCELL ASIC's. Other classes of faulty ASIC's were found. ASIC's which had very large spread of gain in all channels, 30 to 70 mV/fC, were classified as "Large gain spread" ASIC's. ASIC's which threshold uniformity in all channels were worse than expected after trim tuning were classified as "Trim-DAC loading failed" ASIC's. ASIC's which responses were faulty below a threshold because of negative offsets were classified as "Negative offset" ASIC's. ASIC's which had abnormal calibration line were classified as "Abnormal calib line" ASIC's. Figure 2 shows an example of such "Large gain spread" and "Trim-DAC loading failed" ASIC's.

Figure 2: Example of "Large gain spread" (top plot) and "Trim-DAC loading failed" ASIC's (bottom plot). There are 6 ASIC's in a plot.

By the middle of August 2002, we have fabricated 120 hybrids with ASIC’s and 98 modules in Japan. We obtained 102 hybrids without defective ASIC’s and 93 electrically good modules. The rate of hybrids with defective ASIC’s was 9.7% and would be reduced to a smaller value by improving the ASIC screening that eliminates “Large gain spread”, “Trim-DAC loading failed”, "Negative offset", and "Abnormal calib line" ASIC’s.

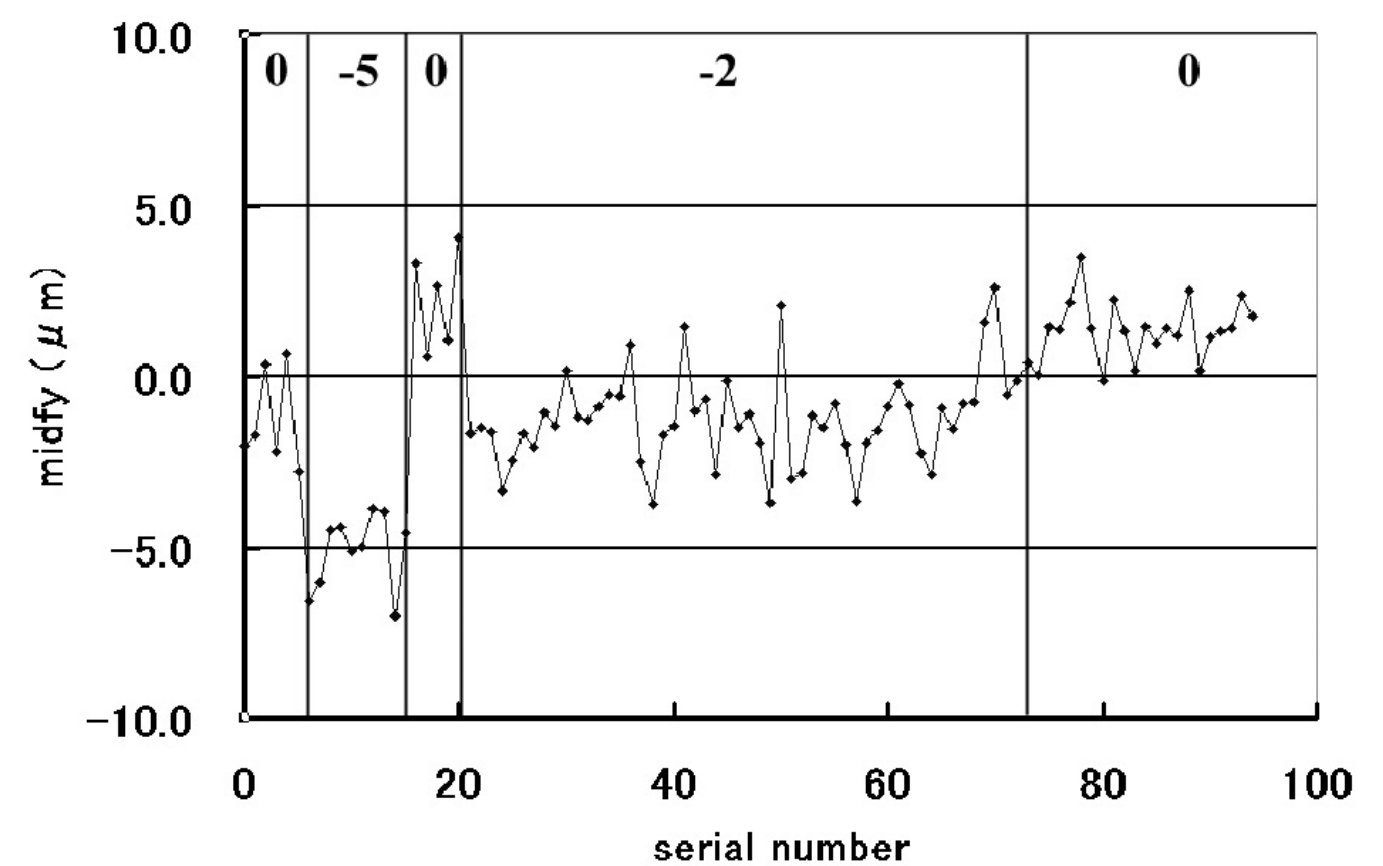
In Metrology, the positions of the sensors and shape of the modules were surveyed with a 3-dimensional metrology machine [12] . One of the critical parameters that was difficult to achieve was the alignment of the upper and the lower sensors, called "midyf", the deviation of centre of the upper pair relative to the centre of the upper and the lower pairs. Figure 3 shows the "midfy" in serial order. The tolerance for the "midyf" was +/- 5 µm. Four modules were out of tolerance in early phase. Together shown in the figure is the assembly parameter that controls the "midyf". The parameter was set to -5 µm in that phase, which was later identified as mistake. The coincidence of the assembly parameter and the measured "midyf" was good and the spread of the "midy" around central values was well within the specification.

Figure 3: The measured upper-lower alignment "midfy" in serial order. The values of the assembly alignment parameter are also shown in the plot.

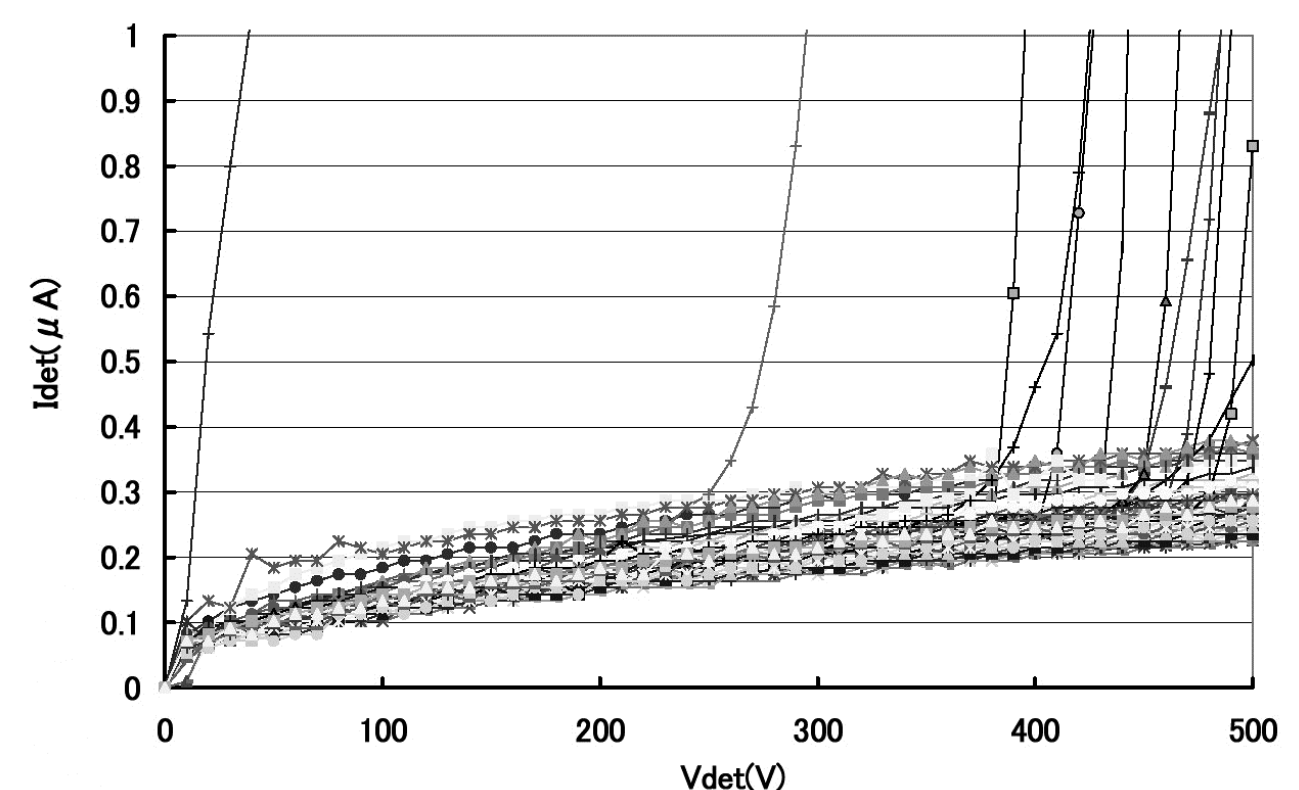
Behaviour of leakage current was measured for the bias voltage up to 500 V at a temperature of 15 ˚C. Figure 4 shows the I-V curves of 95 modules. Most of the modules draw little current, less than 400 nA, smoothly up to 500 V, which were consistent with the sum of four sensors used in the modules. Two modules showed breakdown (we call it "microdischarge") below 350 V and 10 modules above 350 V. The former 2 modules were identified to have damages on the bonding pads that were made at the time of bonding repairing. The microdischarges above 350 V were accepted. In experiment, the bias voltages required are below 200 V initially, and after type inversion and growth of full depletion voltage due to radiation damage, the microdischarge will not occur for the voltages to deplete the sensors in 10 yrs of operation. This has been confirmed in irradiated sensors. Also, the increased currents decayed down to normal currents after applying the bias voltages, e.g., 500V, for hours, a characteristic of microdischarge.

Figure 4: I-V measurement of the modules

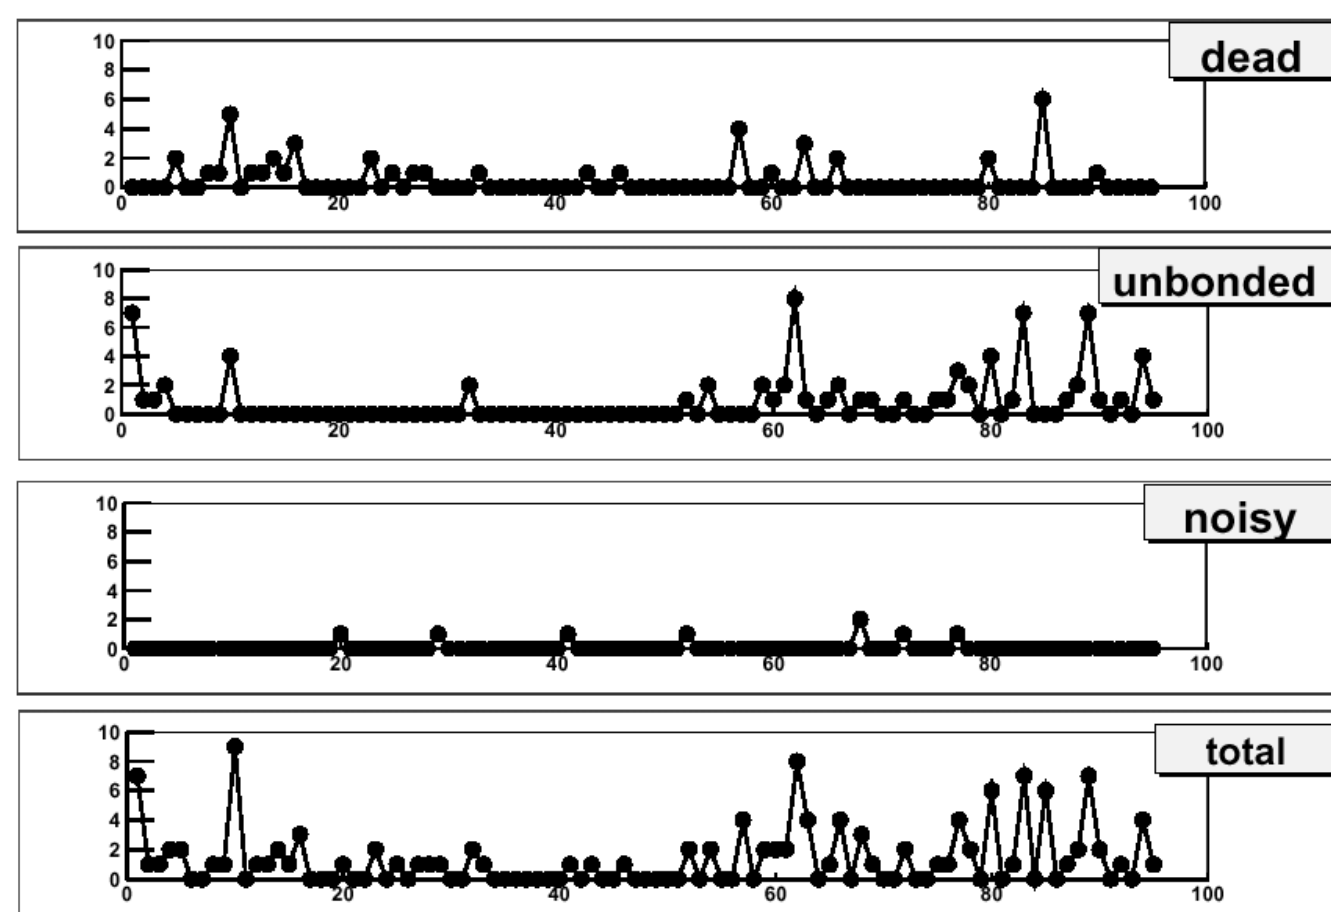
Figure 5 shows the number of defective channels in a module in serial order. The plot “dead” was the number of channels of DEAD, STUCK, or UNTRIMMABLE channels that were subsequently masked by the channel mask registers. The plot “unbonded” was the channels that had the noise equivalent in the hybrids (ENC < 700 e). The plot “noisy” was the channels with ENC > 2000 e. The average ENC was found to be 1695 ± 53 (stat.) ± 200 (sys.) e from all channels in all modules. The plot “total” was the sum of the above. The “dead” and “noisy” occurred randomly. The “unbonded”, however, had a structure: very small number below the module 60 and high above. Below the module 60, re-wire-bonding was made. Above the module 60, no re-wire-bonding was tried, after the finding of the bonding pad damage in the repairing.

Figure 5: Number of defective channels in serial order

A summary of defective channels in modules is given in Table 3. The average of “unbonded” channels is calculated by using the modules greater than 60. The loss of channels was very small, less than 2 channels in average and 9 channels maximum that was still less than 1% of 1536 channels in a module. Although the loss was small, the largest loss was in “unbonded” channels. The reason of “unbonded” is being investigated and could be reduced by improving components and also by introducing re-wire-bonding with improvement in the process damaging the bonding pads.
